| Title: Preliminary Site Investigation (Soil Contamination) | | | | | |
| 07/07/25 | 0.1 | Draft for client review | M. Stewart | P. Walker | D. Velluppillai |

# 1 Introduction and background

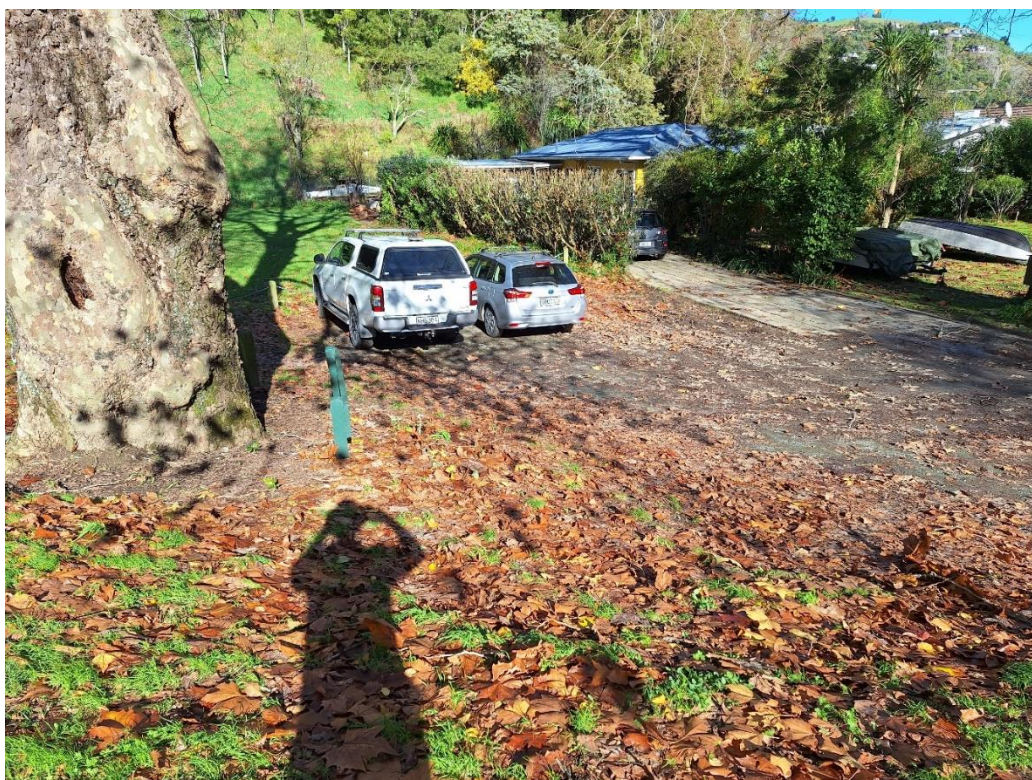
- Gravelled Hanby Park car park at the end of Mill Street, situated 15 m from the base of the existing stopbank (Photograph B.2).

*Photograph B.2: Car park area at the end of Mill Street within Hanby Park.*

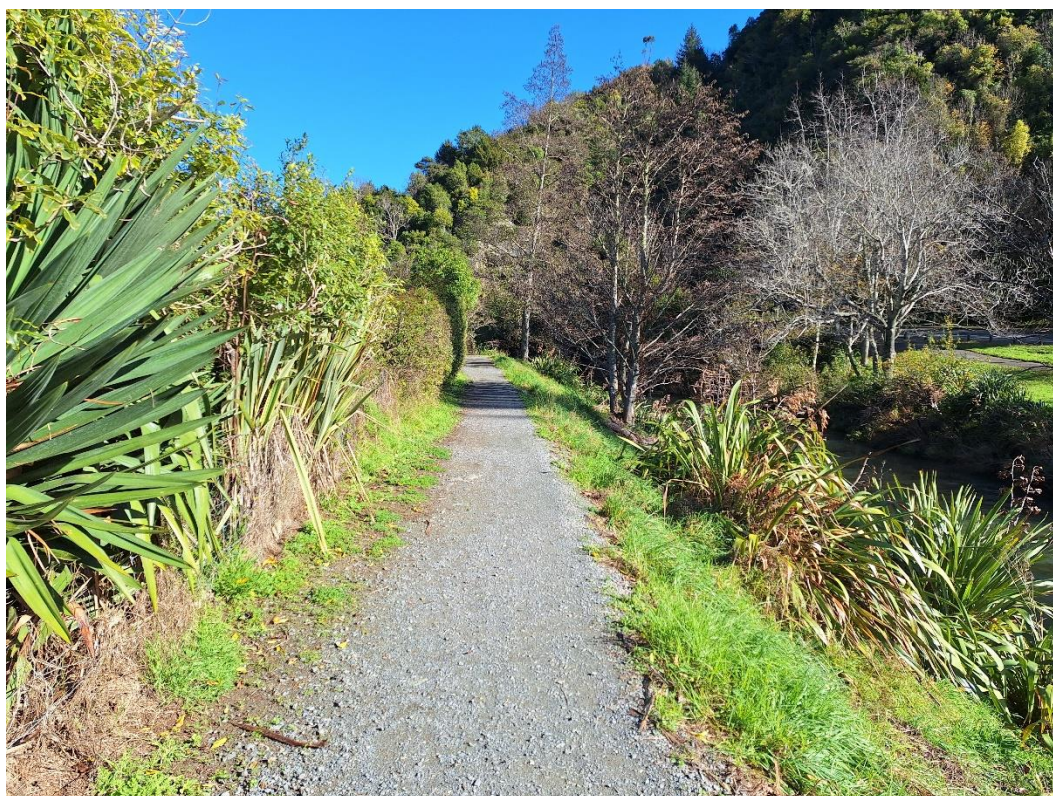
- Gravel walking path on the true left side of the Maitai River (Photograph B.3).

*Photograph B.3: Gravel walking path on the true left site of the Maitai River.*

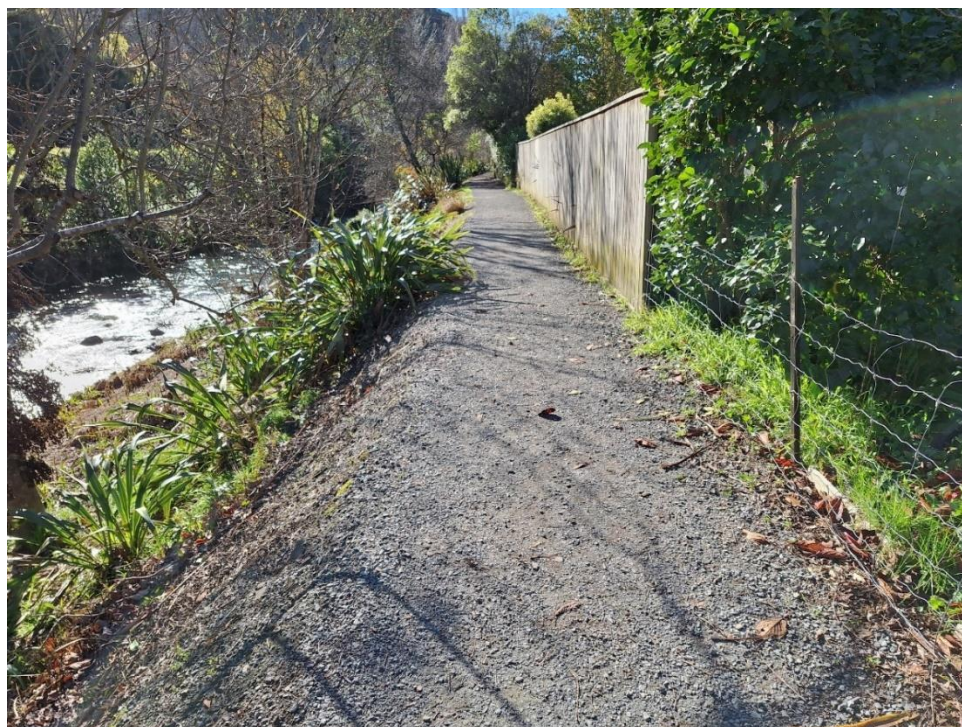
- A gravel path runs along the top of the current stopbank on the true left side of the river (Photograph B.4 and B.5).

*Photograph B.4: Gravel path on the true left side of the Maitai river.*

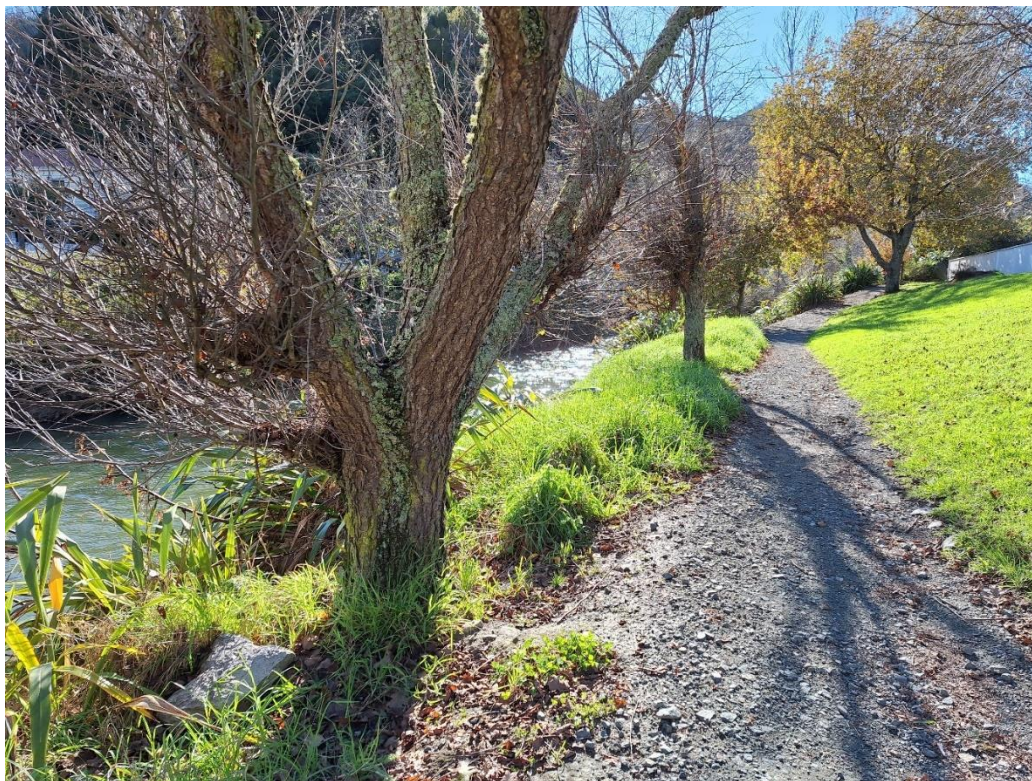
*Photograph B.5: Gravel path on the true left side of the Maitai river.*

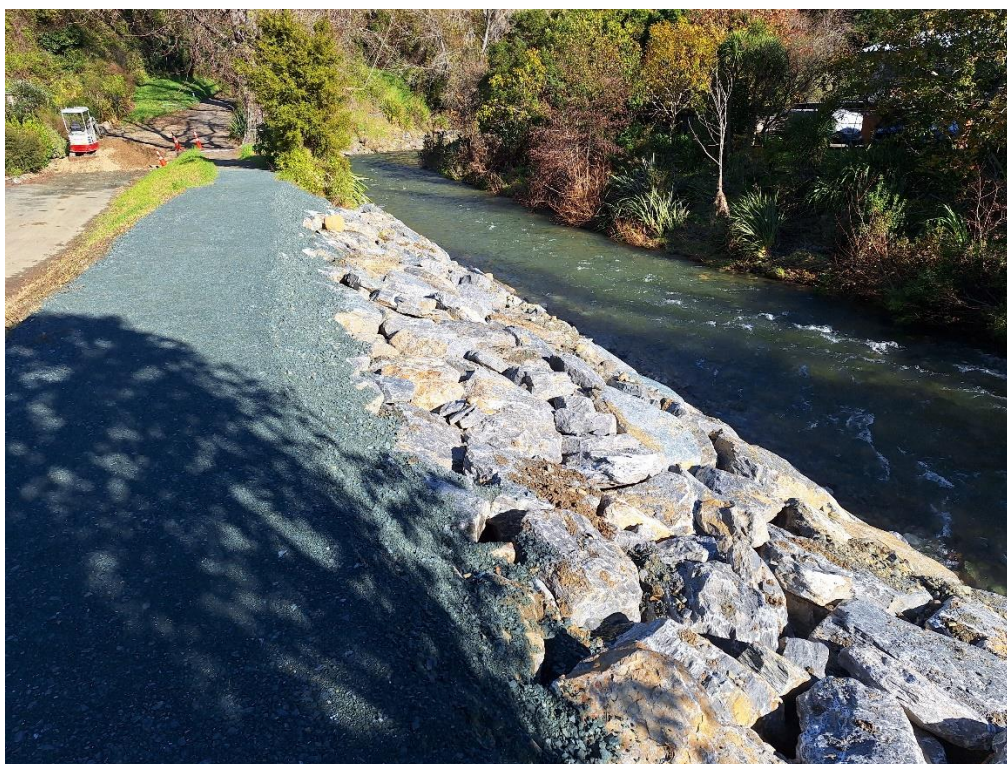
- A gravel path runs along the top of the current stopbank on the true left side of the river (Photograph B.6). Some riprap erosion protection is in place along the riverbank.
- At the time of inspection, a pile of gravel (6 m x 3 m) with a small excavator sitting on top was located at the end of Clouston Terrace (Photograph B.8).

*Photograph B.6: Recently laid gravel on the gravel path which runs along the top of the stopbank of the true left side of the river. Boulder protection can be observed on the river bank.*

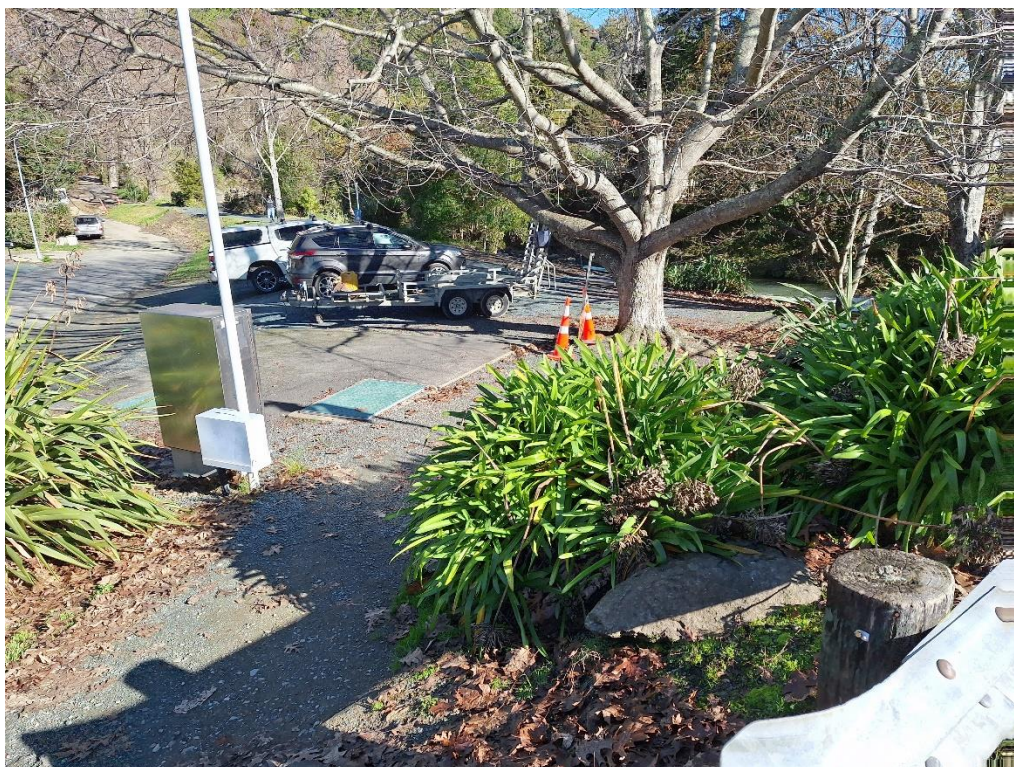
*Photograph B.7: Car park area on the true left side of the stopbank, south of the Nile Street Bridge.*

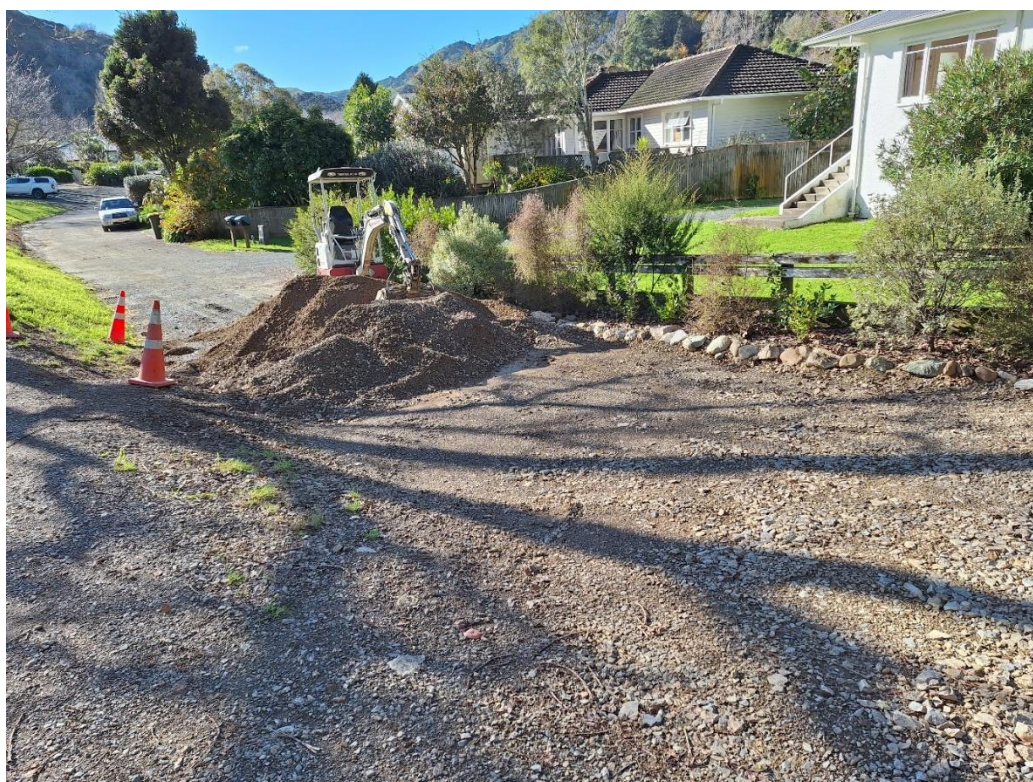
*Photograph B.8: On the road at the end of Clouston Terrace is a pile of gravel (6m x 3m) with a small excavator sitting on top of the pile.*

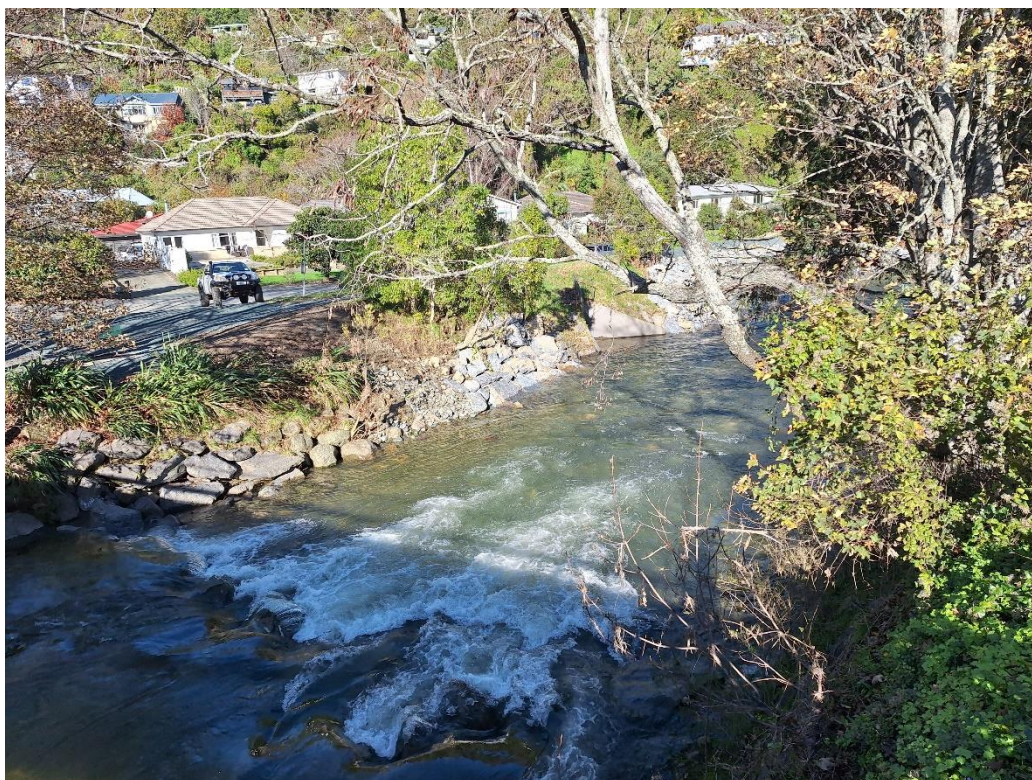
*Photograph B.10: The true left banks of the Maitai river. Large cobbles and boulders line the banks.*

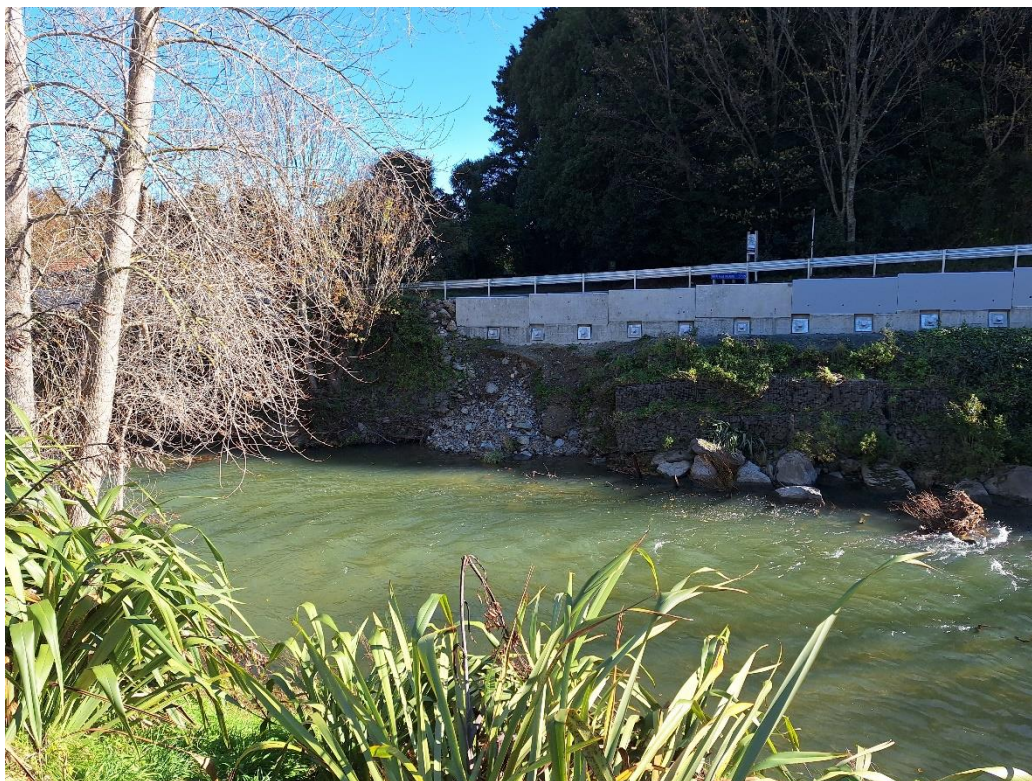
- A brick foundation, potentially a retaining wall, was observed on the riverbank at the back of 212 Nile Street and beside 210A Nile Street, however, access to this area was limited.
- Some remedial works and gabion baskets as scour protection were visible along part of the Maitai Road section of the north of the bridge, with small slips evident (Photograph B.11).

*Photograph B.11: The true right banks of the Maitai river and the barriers of Matai Road. A previous slip is evident and gabion baskets as scour protection can be observed.*

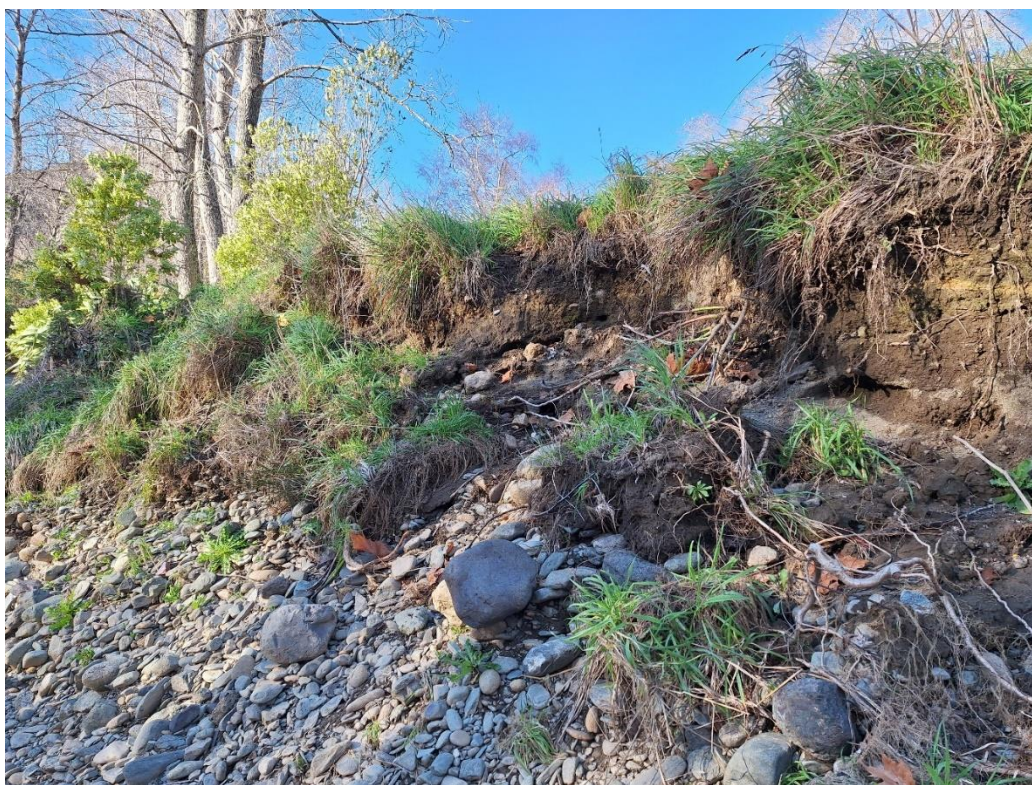
- Near (but not within) portion 1, there was visible scour of the true left side of the riverbank exposing black carbonaceous material, which could be of anthropogenic origin, 1.5 m in length (Photograph B.13). Also observed within the scour was a ceramic pipe fragment. Fragments of asphalt and a piece of rail material were scattered across the surface but not embedded in the scour (Photograph B.15). It is not clear whether this material was derived from the riverbank, deposited from the river or is of anthropogenic origin.
- Also near (but not within) portion 2, there are rammed railway irons along the eastern end of portion 2, as scour protection (Photograph B.16). The surface above the rammed railway irons appears to be capped, preventing observations of the material beneath the capping.

*Photograph B.12: Area of visible scour on the true left side of the riverbank.*

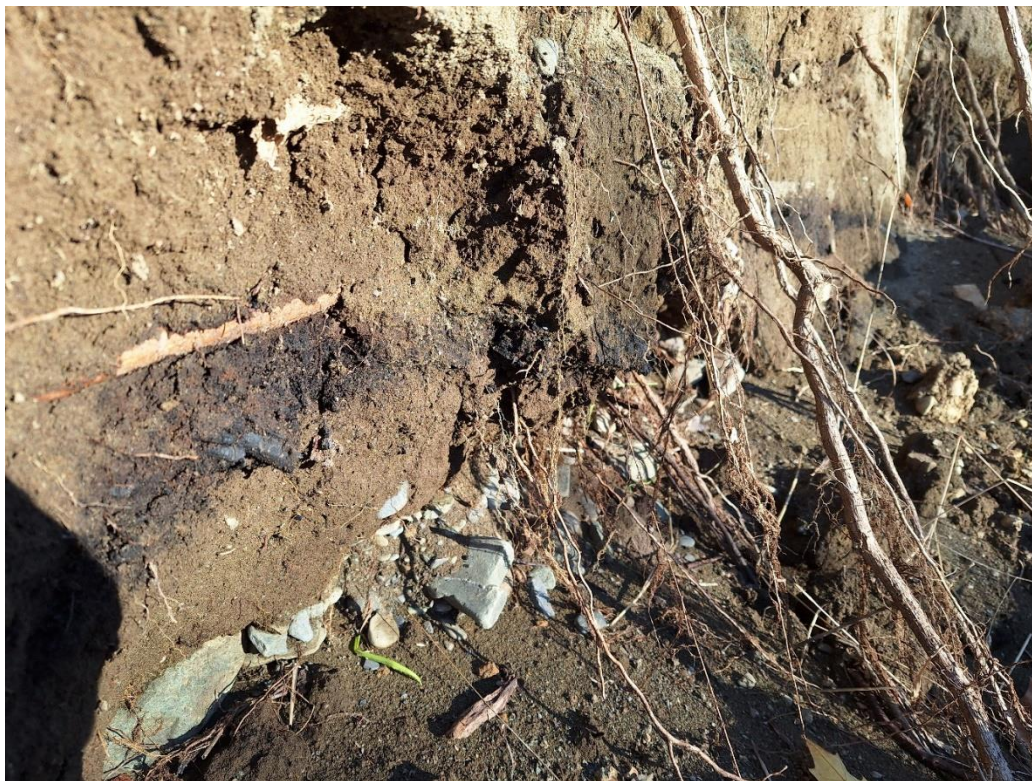
*Photograph B.13: Black carbonaceous material exposed within the scour on the true left side of the river bank.*

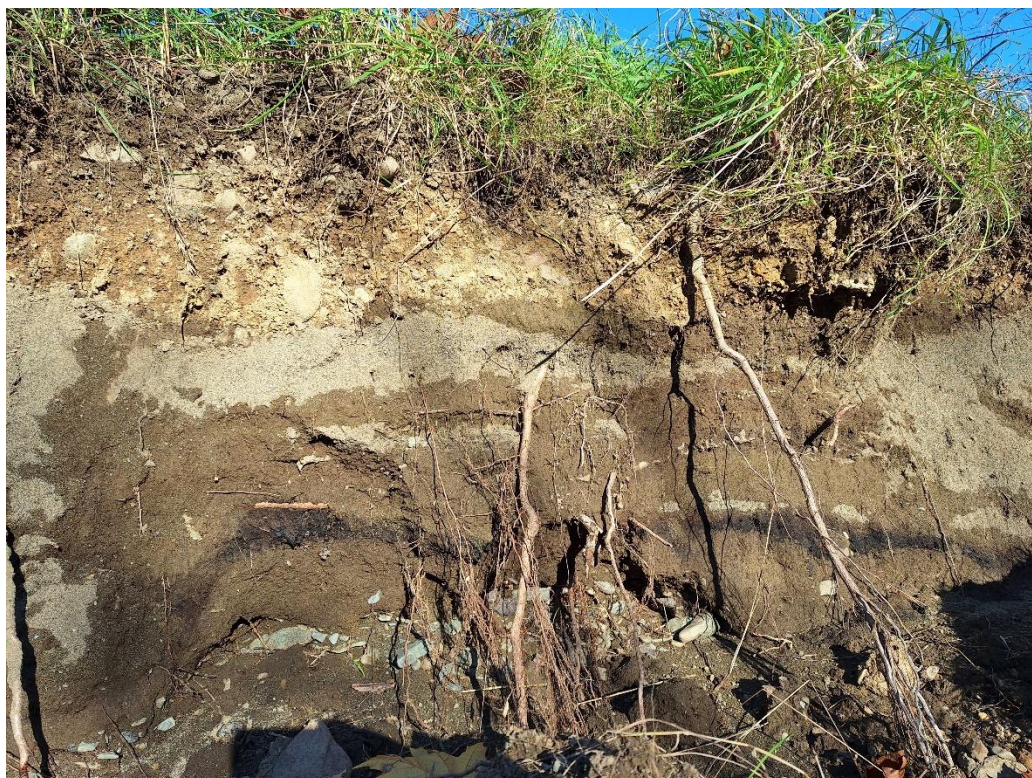
*Photograph B.14: Black carbonaceous material exposed within the scour on the true left side of the river bank.*

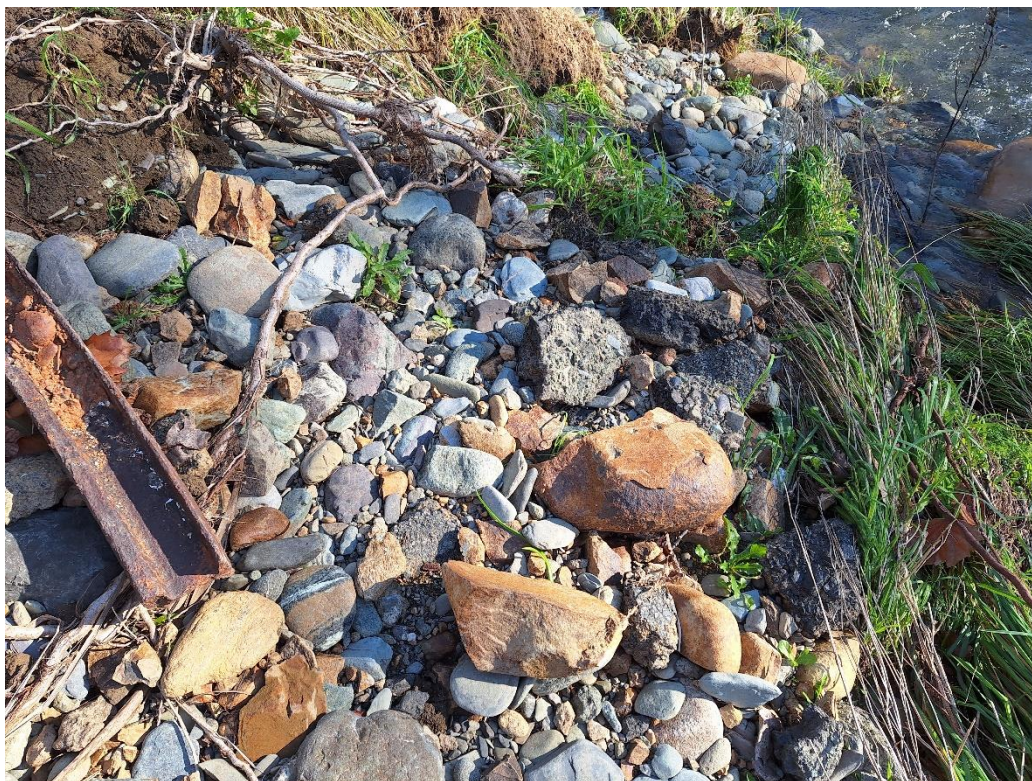
*Photograph B.15: Rail material scattered on the surface of the scoured-out area.*

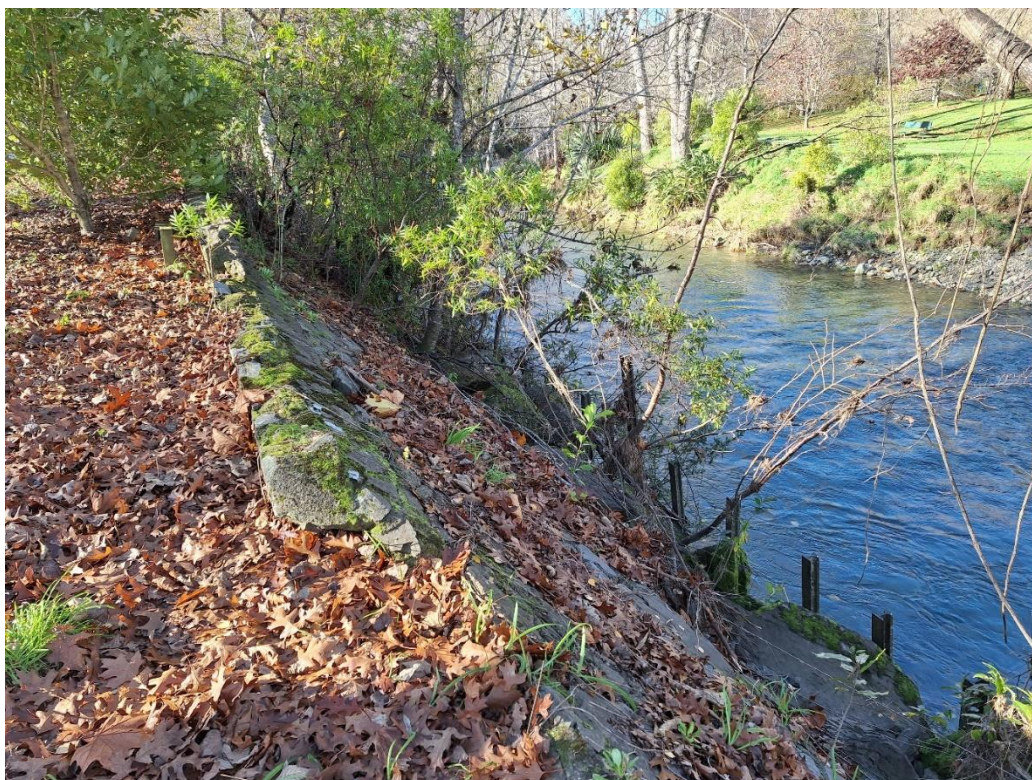
- Maintenance, modification and repair to the Maitai River was observed to be minimal, with little to no indication of use of fill. Additional measures of protection such as boulder protection, gabion baskets and rail material have been used to reinforce the riverbanks.

*Photograph B.16: Rammed railway irons line the river bank as scour protection.*
