## **Maitai Flood Improvements: Hanby Park to Clouston Terrace**

### **Amanda Young 22 August 2025**

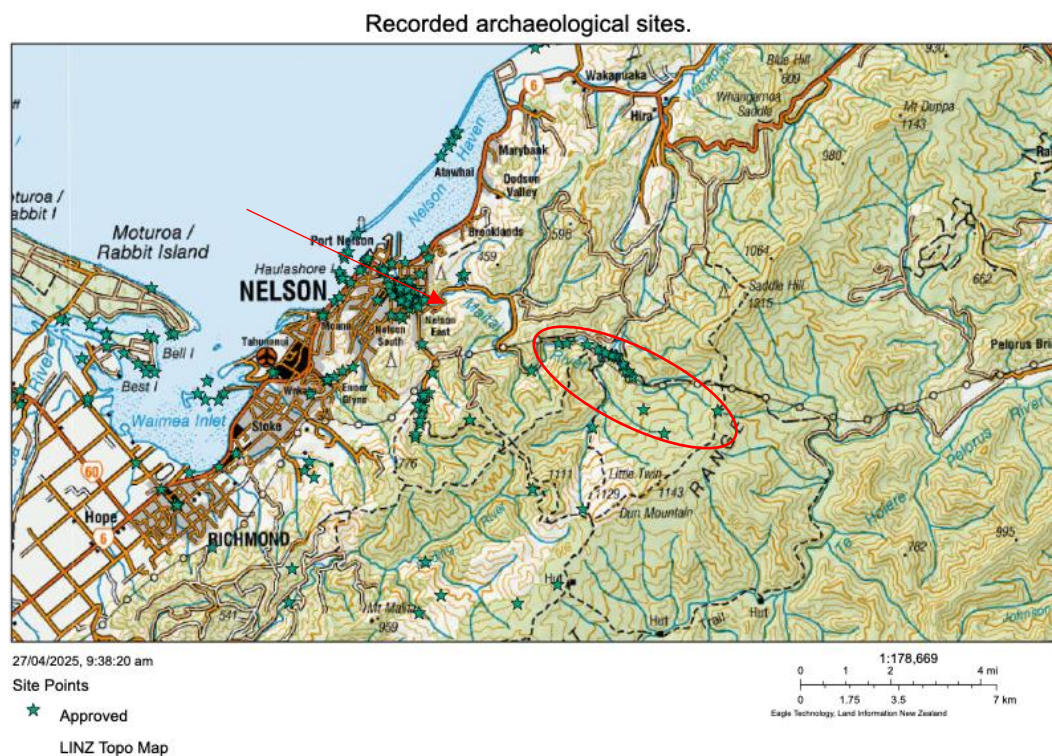
Figure 9: Recorded archaeological sites in the Nelson area. The red arrow points to the project area. The red oval indicates the nearest pakohe working sites.

The nearest pakohe working sites are upstream beyond Smiths Ford<sup>11</sup>. There are sixteen pakohe working sites where evidence of flaking and working of either river boulders or material brought down from quarries in the Mineral Belt has been found. At least one of the sites probably also represents a kāinga and there are likely to be further occupation evidence associated with the recorded pakohe working.

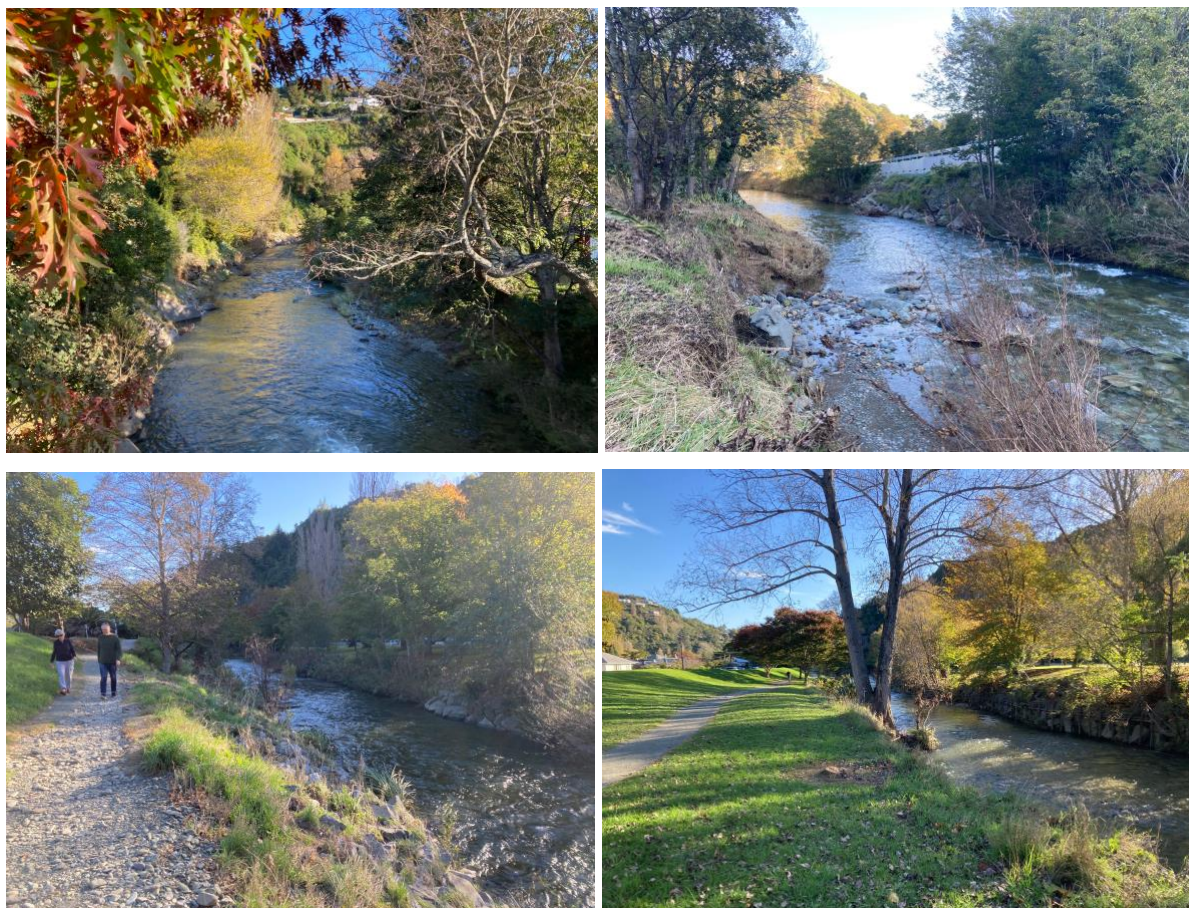
Figures 11-14: Project area from Clouston Terrace to Hanby Park (24 April 2025).

A site visit was made to the project area on Thursday 24 April 2025. Plans were supplied by Tonkin & Taylor. The banks of the river and location of the earthworks were examined. The river was running high and so only limited examination of the river bed was carried out. Visibility of the river banks varied from poor to good depending on vegetation, cladding and erosion.

No archaeological material was found.

The project area is an altered urban and semi-rural environment. There is a variety of previous attempts at flood and erosion control including stopbanks, gabions, stone walls and posts. There are paths along the river banks and evidence of previous bank modification including artificially flattened areas.
