## **Maitai Flood Protection Works: Queens Gardens Stormwater Pipe**

### **Amanda Young 25 February 2025**

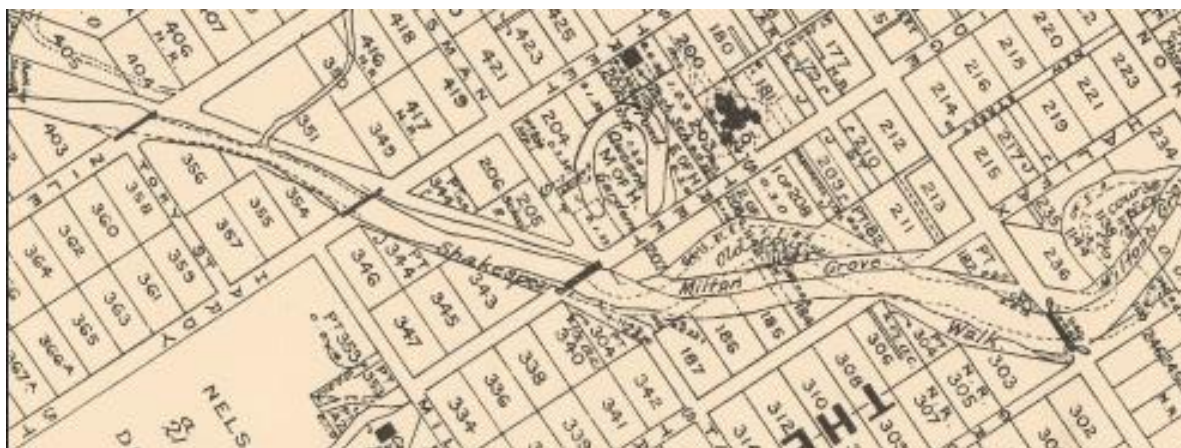
Figure 2: Plan of the City of Nelson and Tahunanui Town District. NZ Lands & Survey, Wellington. 1923. ([www.natlib.govt.nz](http://www.natlib.govt.nz)).

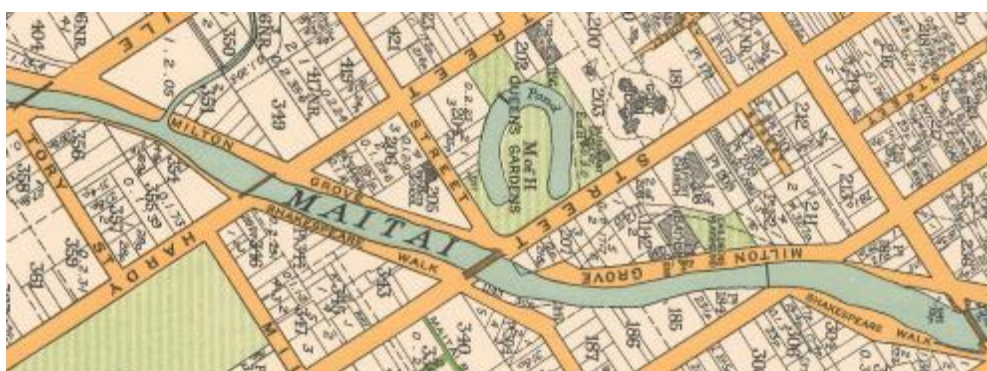
Figure 3: Plan of the City of Nelson and Tahunanui Town District. NZMS16. NZ Lands & Survey, Wellington. 1931 ([www.natlib.govt.nz](http://www.natlib.govt.nz)).

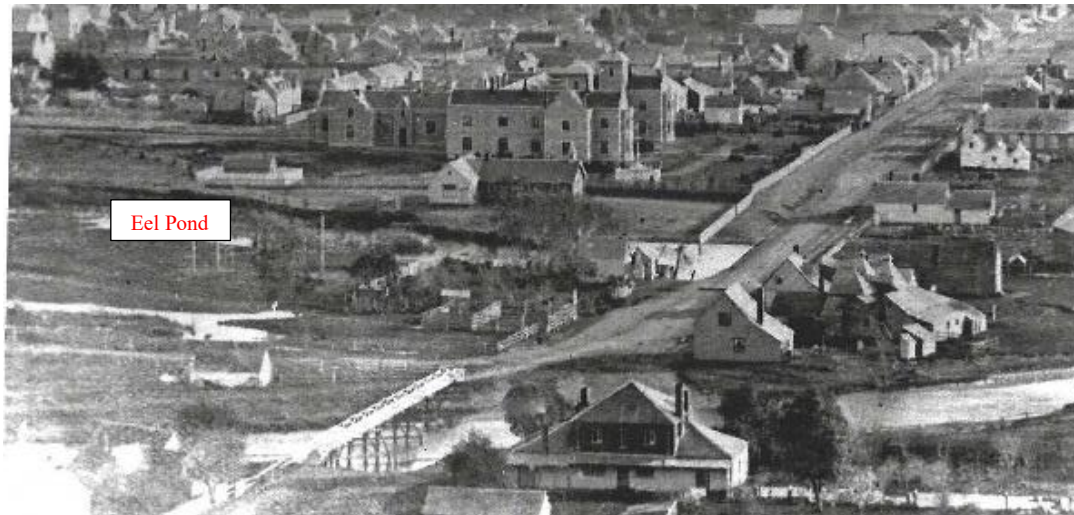
Figure 6: The Maitai and Bridge Street in the early 1860s. The Eel Pond is visible with the Matthew Campbell School (incorporated into The Suter) and Provincial Government buildings to the rear. Cropped photograph. Nelson Provincial Museum C939.
