August 2022 rainfall event summary

**PC29 – S32 Report
Appendix 2C**

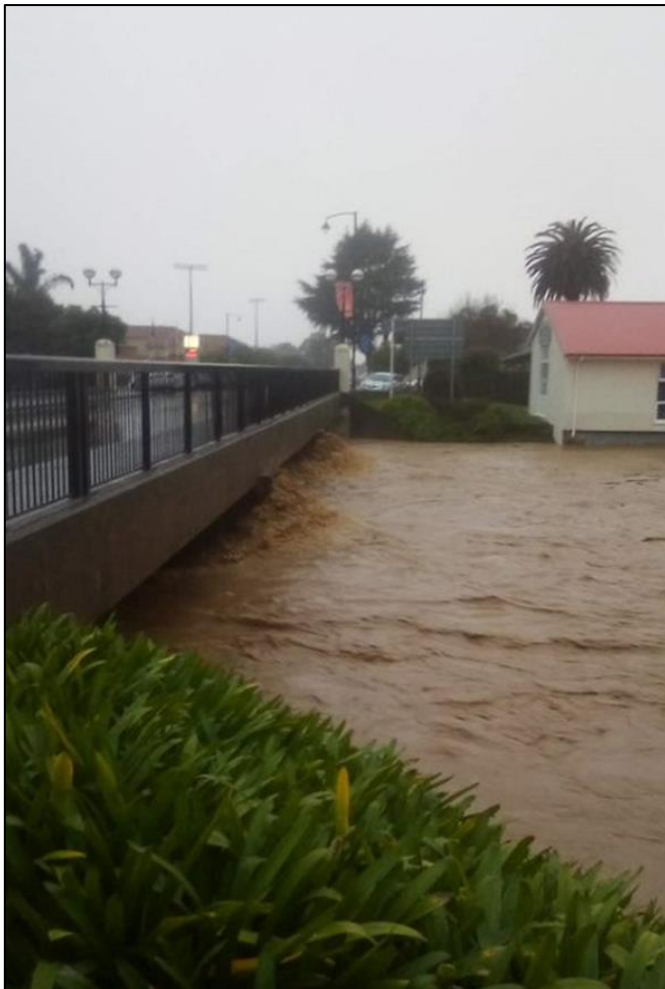
Figure 1 - Trafalgar Street bridge, Nelson City Centre, mid-afternoon 17 August 2022, approximately 322m³/s

The total rainfall for the 16-20 August 2022 was 742 mm (measured in The Brook stream catchment). The Maitai at Forks rain gauge had 694mm over the same period. The hills behind Nelson received at least double the expected rainfall. The image below shows the Maitai River at the Trafalgar Street bridge, in the city centre mid-afternoon 17 August 2022. The flow is approximately 322m³/s. The second image is of The Brook also on 17 August 2022, the day of the highest Maitai River flows.

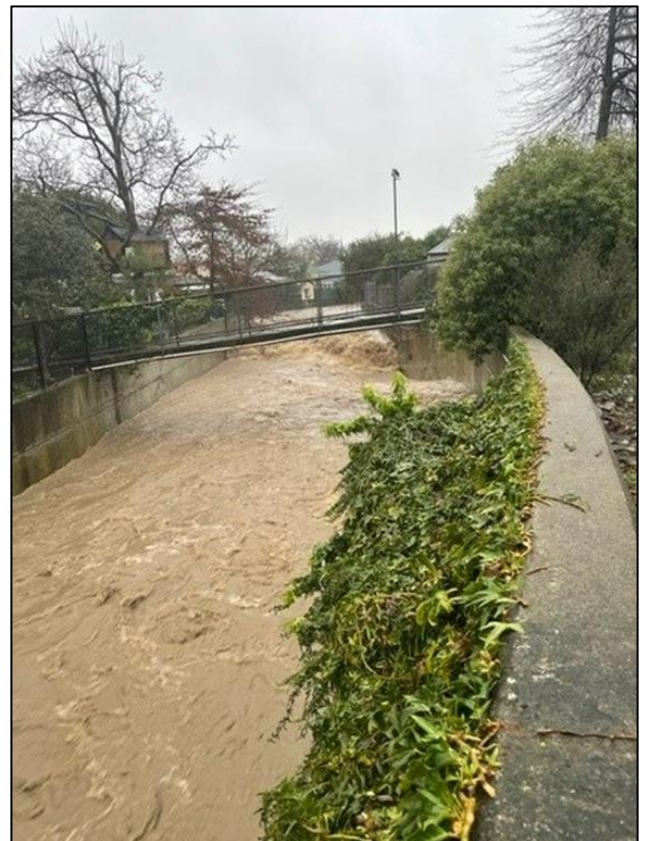
Figure 2 - The Brook stream, Nelson, looking downstream towards Wards Reserve 4pm 17 August 2022
